DEGRADATION OF MATERIAL PROPERTIES OF A CUPRONICKEL ALLOY IN AMMONIACAL ENVIRONMENTS

**Commander DC Agarwal, Indian Navy and Commandant (JG) Alankar Singh Indian
Coast Guard**

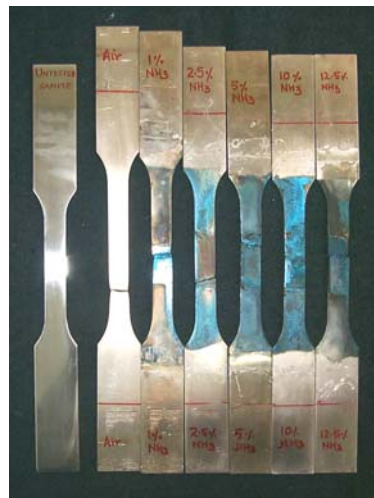
Fig 2 Tested samples

Fig. 2 shows an optical view of the as-tested specimens. It clearly showed a systematic reduction in the specimen elongation, from the air-tested specimen to the specimens tested with increasing concentrations of ammonia, similar to the trend observed in Fig. 1. The observed surface corrosion and cracking became more severe with increasing ammonia concentrations, and the corresponding specimen fractures became more and more brittle (Figs. 3a and 4a).

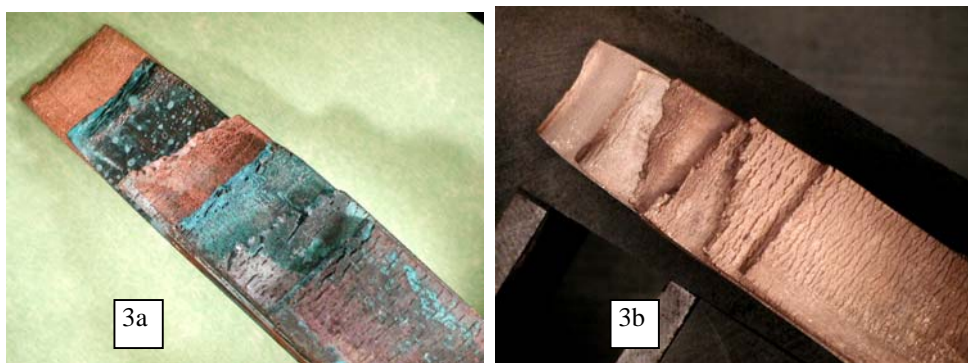
The air tested specimen showed a completely ductile fracture. The 1% ammonia specimen did not exhibit surface cracks, but a non-ductile fracture was visually evident. The specimens tested at 2.5% and higher ammonia concentrations showed distinct surface SCC and increasingly brittle fractures. The failure in the 12.5% ammonia sample was completely brittle and displayed a very high density of surface cracks. Fig. 5 shows a cross-sectional views of the specimens. It confirmed a brittle and rough fracture that had originated from multiple surface (SCC) cracks in higher concentrations of ammonia.

Fig 3 Surface cracks in (L to R) air & 1% to 12.5% ammonia (a) as tested (b) after cleaning

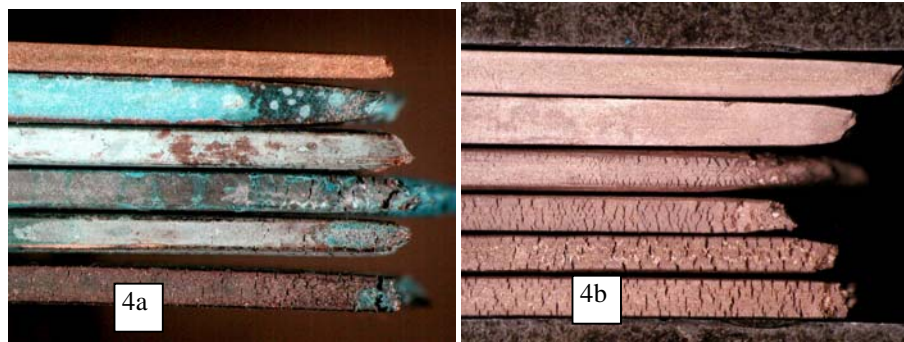
Fig 4 Side view cracks (top to bottom) air & 1% to 12.5% ammonia (a) as tested (b) Cleaned

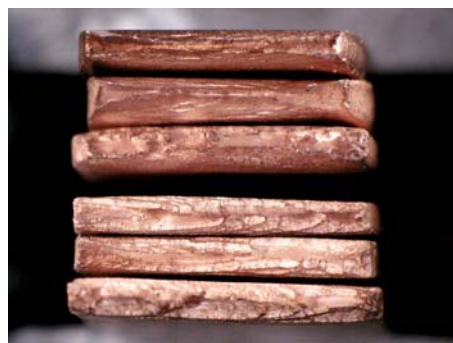
Following this initial evaluation, one half of each fractured sample was ultrasonically cleaned in a mild ALCANOX solution to remove the surface corrosion products. The cleaned samples (Figs. 3b, 4b and 5) were then examined under a stereo-optical microscope.

Fig 5 X-section view, air & 1% to 12.5% ammonia

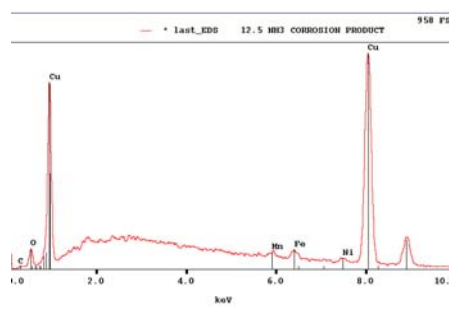
The corrosion products observed on the fractured surface of the specimen tested in air was mainly copper oxide(s). The specimens tested in various concentrations of aqueous ammonia all showed similar EDX spectra from the corrosion products (Fig. 6). The low observed amounts of Ni, Mn and Fe in the corrosion products indicated that the copper was being preferentially attacked. Some dissolution of these elements in the running test solution is also possible.

Fig 6 EDX of Corr. Products in ammonia

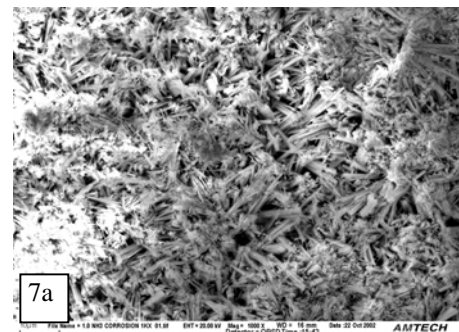
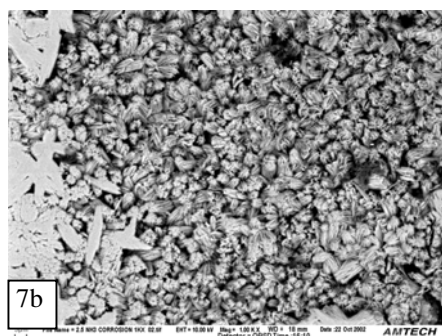
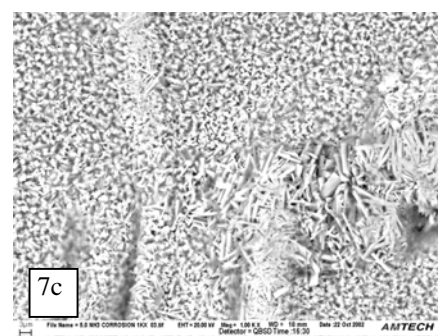
All the aqueous ammonia tested specimens exhibited crystalline corrosion products. Fine crystalline corrosion products were observed at low ammonia concentrations (Figs 7a and 7b). Then, with increasing ammonia concentrations, the corrosion product crystal size increased (matured) for up to 5% ammonia and then the size remained essentially unchanged at higher ammonia concentrations (Figs. 7c, 7d and 7e).

Fig 7 SEM of Corrosion Products (a) 1% (b) 2.5% (c) 5% ammonia

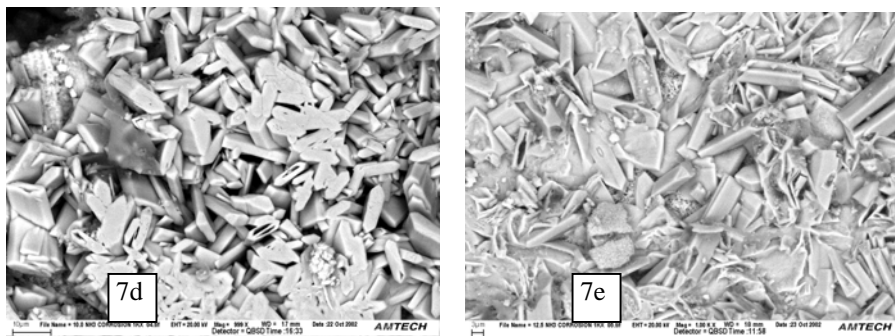
Fig 7 SEM of Corrosion Products (d) 10% (e) 12.5% ammonia

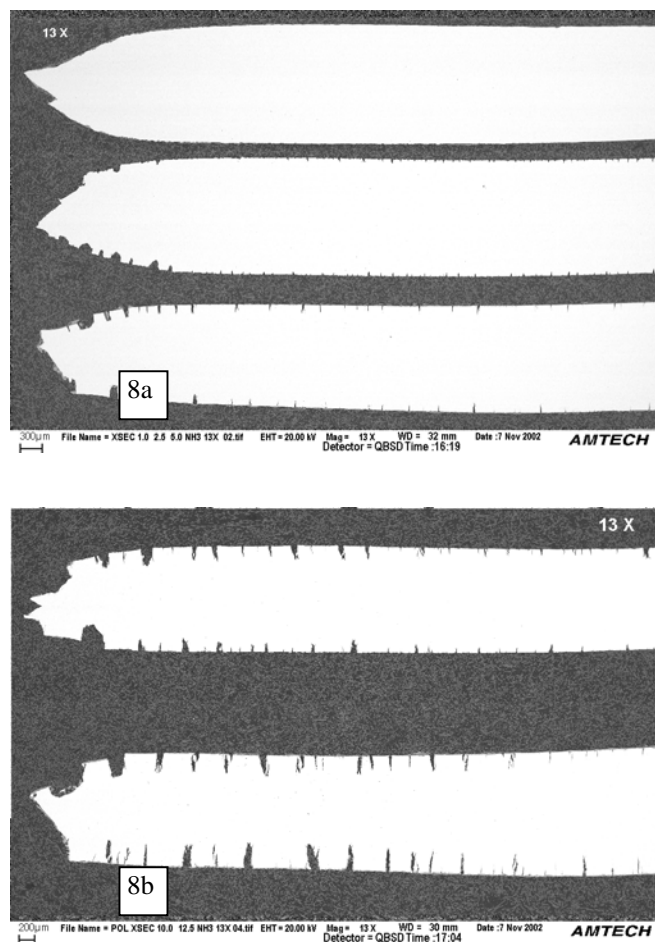
Figures 8a-b show low magnification cross-sectional SEM views from the polished cross-sections from 1% to 12.5 % ammonia-tested samples. With increasing ammonia concentration, the fractures became increasingly brittle and the depth penetration of the SCC cracks also increased significantly. The 1% ammonia sample did not show any cracks, but a 26-micron thick general surface corrosion layer was observed in this sample. The sample tested in 1% ammonia appeared to have failed in a ductile mode (Fig. 8a top). However, some influence of other possible failure mechanisms could not be ruled out at this early stage.

The maximum SCC crack penetrations observed in 2.5, 5.0, 10.0 and 12.5 % ammonia samples were 89, 134, 211 and 401 microns, respectively. The SCC cracks had initiated at both the top and the bottom, surfaces in these samples. Increasing crack/corrosion penetration with increasing ammonia was a clear indication that SCC was the operative failure mode in these samples.

Fig 8 Polished x-sec 13X (a) 1%, 2.5%, 5% (b) 10%, 12.5% ammonia

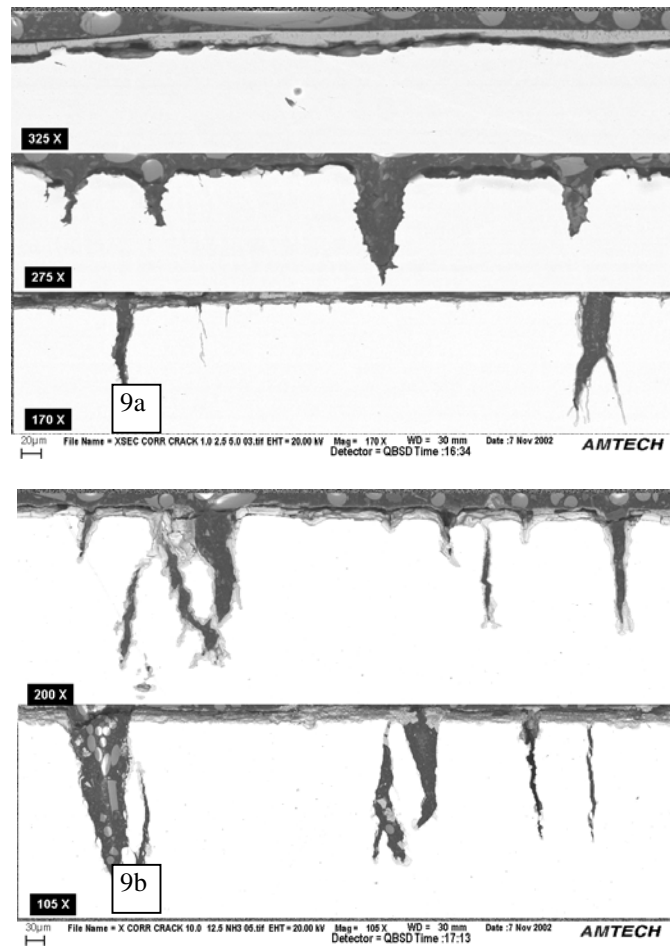
Typical cracks observed in the present polished samples were also examined at higher magnifications under the SEM to characterize the crack initiation and propagation mechanisms (Figs. 9a-b).

No cracks were observed in the 1% ammonia sample. The 2.5% ammonia sample showed zagged cracks, which are indicative of an intergranular corrosion attack, in the near-surface regions. The crack initiation regions of the 2.5 to 12.5 % ammonia samples had been obliterated by a severe corrosion. The crack propagation in the 2.5% and higher ammonia concentration tested samples had occurred by a transgranular SCC mechanism. The observed branching at the tip of the cracks in the 5% ammonia sample confirmed the presence of transgranular SCC. The SCC cracks in the 10.0 and 12.5% ammonia samples were severely corroded and, therefore, did not show the finer fracture features generally associated with the intergranular and transgranular SCC.

Fig 9 SEM -cracks un etched (a) 1%, 2.5%,5% (b) 10%, 12.5% ammonia

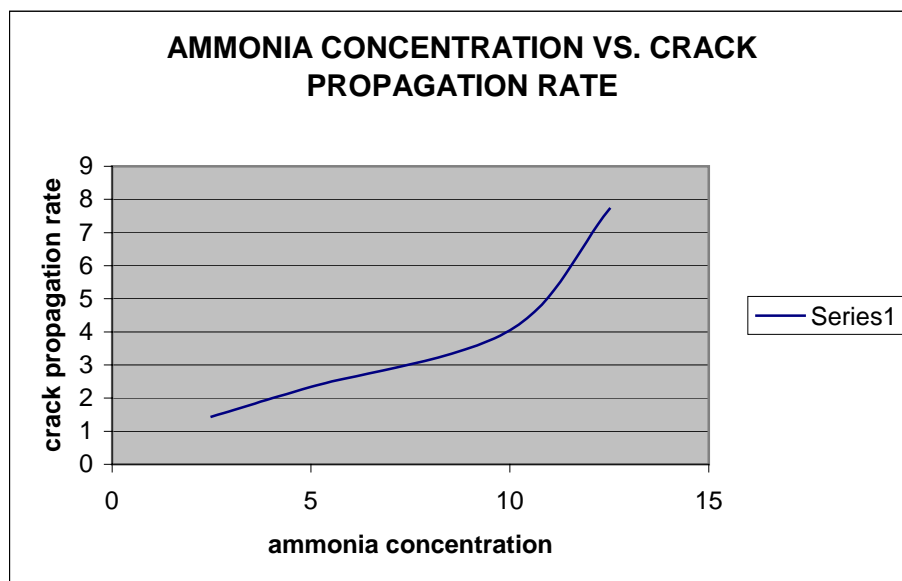
It was also observed that with increasing ammonia concentrations , the fractures became increasingly brittle ,and the depth penetration of the stress –corrosion cracks increased significantly. Using the results of depth penetration and time to failure a relation ship between ammonia concentration and crack propagation rate can be generated (fig 10.).

It was observed that upto about 5 % of concentration of ammoniacal solution, the crack growth rate follows a linear relationship, beyond which there is exponential increase. The linear relationship range may be usefully utilized in predicting the failure time under low concentration of ammonia after accelerated lab testing at about 4 % ammonia concentration.

Fig. 10 shows relation ship between ammonia concentration and crack propagation rate

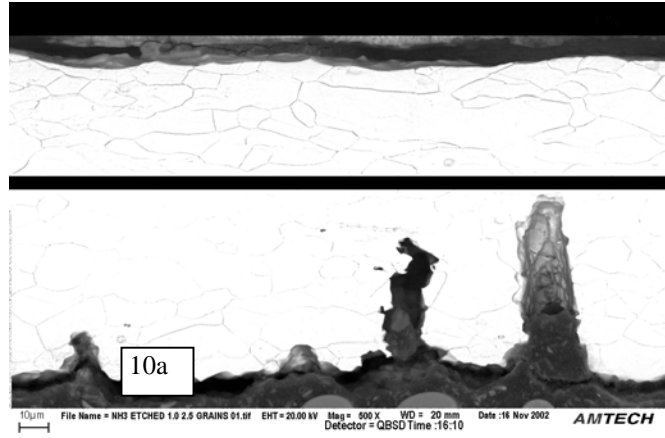
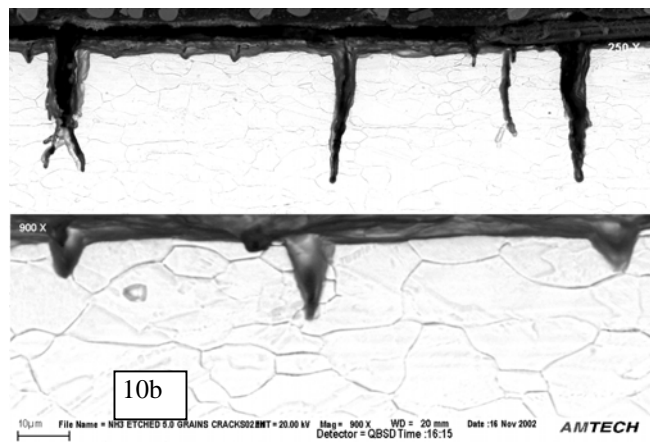
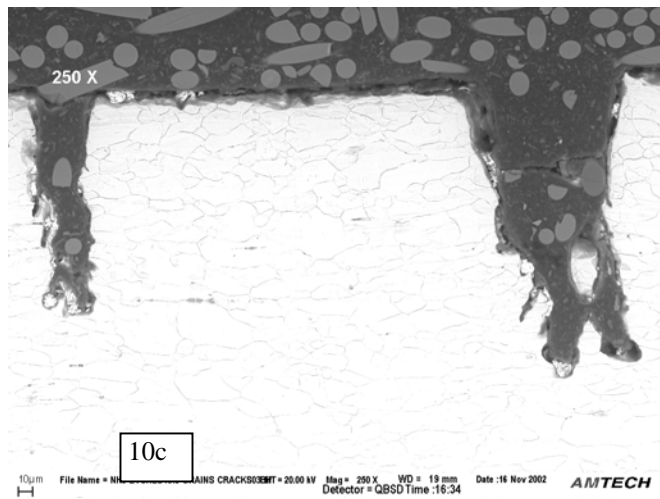
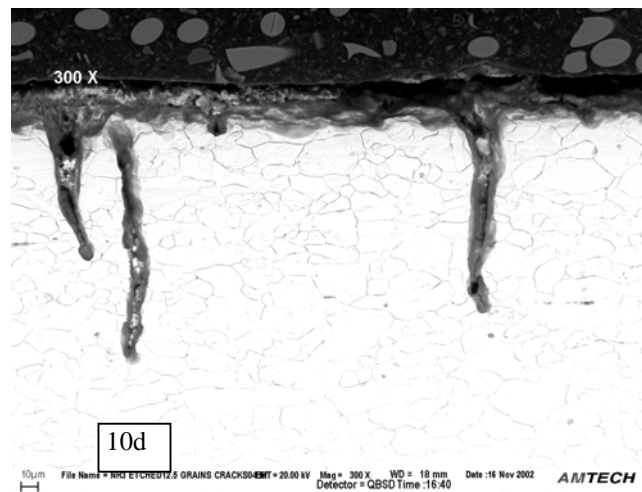
Figures 10 a-d shows the polished and etched cross-sections of the ammonia-tested samples. The 1% ammonia sample shows surface corrosion and no cracks (top photo in

Fig 10a), while 2.5% ammonia sample exhibited largely intergranular cracks (the lower SEM in Fig. 10a, which is from the bottom surface) confirming the SCC. The 5% ammonia tested sample (Fig 10b) clearly showed transgranular cracking even in small cracks (V-shaped). The 10% and 12.5% (Fig 10c,d) ammonia samples also exhibited transgranular cracks. The 12.5% ammonia sample displayed much thicker corrosion deposits on the surfaces as compared to other samples tested at the lower ammonia concentrations.

Fig 10 SEM of etched (a) 1%, 2.5% ammonia (b) 5% ammonia (c) 10% ammonia (d) 12.5% ammonia

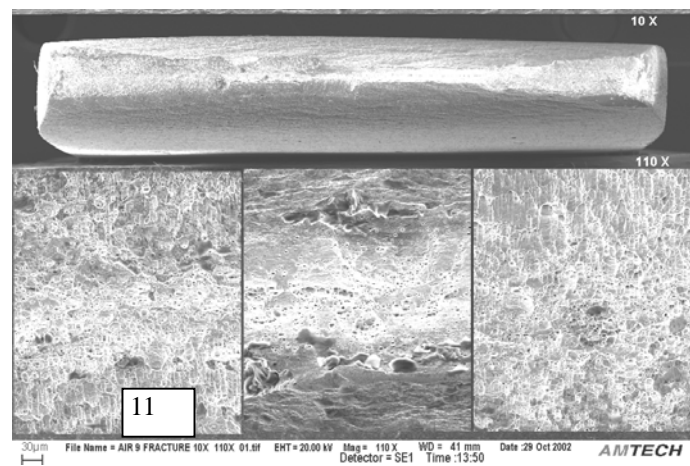
The fracture in the air-tested sample (Fig.11) had originated in the middle-width region of the sample. The sample had failed essentially by a ductile dimple-rupture mode. Small shear lips were observed near the surfaces in the middle region. The presence of larger shear lips and overload fractures at the left and the right ends indicated that the fracture had propagated to both the left and right from the middle region. The right-hand end, where the shear lips were larger, is believed to have failed last. The air-tested specimen displayed significant thickness reduction and plastic deformation in the gage area before the final failure.

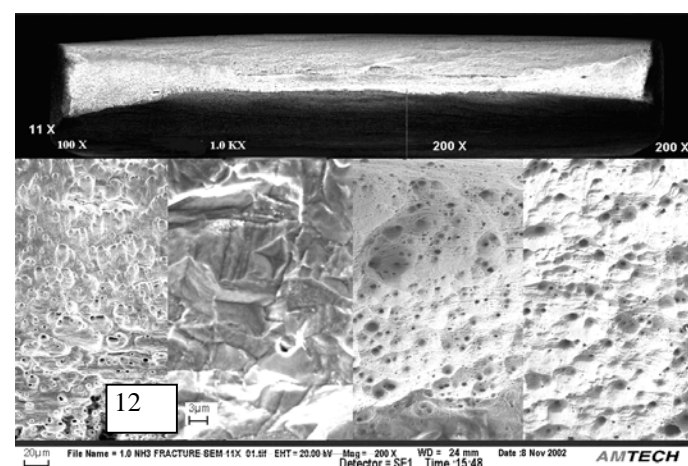
The polished X-section from the 1% ammonia-tested sample did not show any SCC (Fig. 12). However, some corrosion was observed on the fractured faces. The failure had originated in the middle interior (right middle, 200X SEM in Fig. 12) of the sample. The shear lips in this region were small and the fracture itself was more corroded because this area had failed first by a brittle corrosion attack. A typical brittle fracture was observed in the left upper middle portion of the fracture. The fracture progressed to the left and right from the middle region, accompanied by a significant plastic deformation of the sample. Both the left and the right ends showed a combination of ductile fracture with larger shear lips. The final overload fracture is believed to have occurred at the right end, which showed rougher, ductile dimple-rupture type fracture features and less corrosion. A similar failure was previously observed in samples tested in 3.5% NaCl + 10% MgCl₂ + 1% ammonia [9].

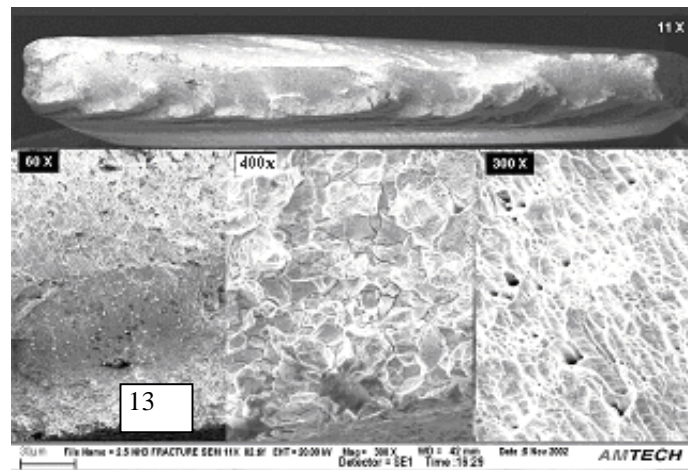
In the 2.5% ammonia-tested sample (Fig.13), the fracture originated from multiple intergranular SCC cracks from the bottom surface. The 60X view in Fig. 13 shows the brittle fracture at the left end. The fracture in this region started at the bottom by intergranular SCC, progressed by transgranular SCC and the top region failed by a ductile shear mode. The bottom middle, 400X SEM photomicrograph shows a magnified view of the intergranular SCC fracture observed at the multiple initiation sites at the bottom surface.

The final fracture in the 2.5% ammonia sample occurred in the extreme right region, where the failure had started in an intergranular fashion at the bottom surface and progressed by a ductile shear mechanism (300X SEM in Fig. 13). The only corrosion observed in this region was in the initiation zone.

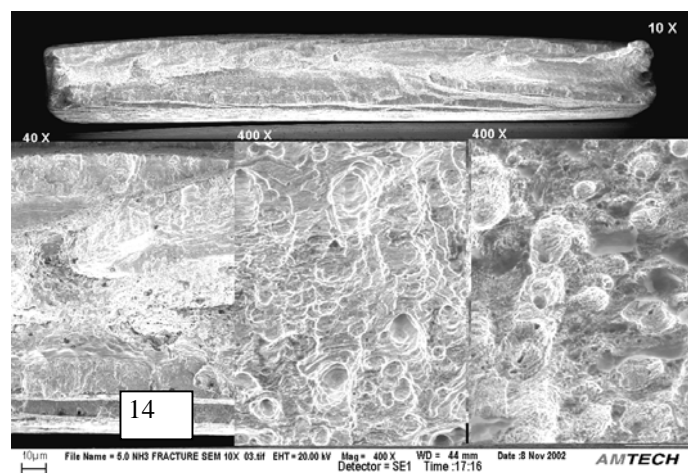
In the 5% ammonia-tested sample (Fig.14), the presence of severe corrosion tended to mask the evidence of the near-surface crack initiation mechanism(s), and the cracks appeared to be predominantly transgranular. This fracture initiated and progressed from multiple origins at both the surfaces to a significant depth. The observed fracture propagation appeared to be by a transgranular SCC mode. There was a narrow ductile region in the middle thickness region of the fracture. The left area (40X SEM in Fig. 14) showed a narrow ductile center region, which is believed to have failed first. The extreme right area ductile region (400X, right SEM in Fig. 14) was corroded and it may have failed before the middle right ductile region (final failure), which was not corroded (400 X, final fracture, middle SEM in Fig. 14).

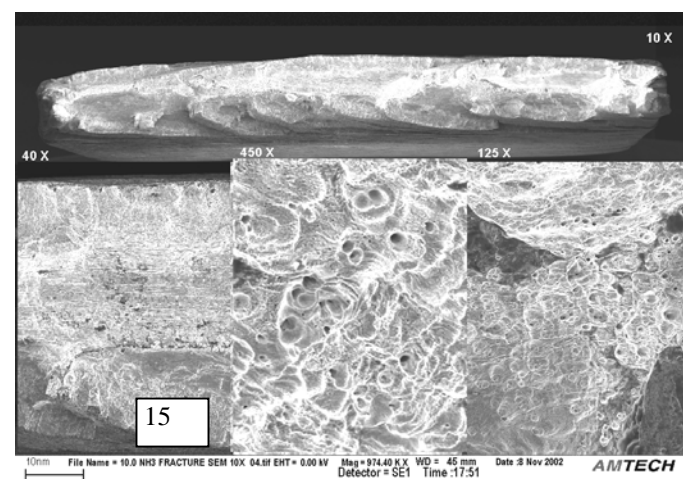
The fracture in the 10% ammonia-tested sample (Fig.15) had originated at multiple locations on both the surfaces and progressed inwards by transgranular SCC to a significant depth of the sample thickness. The details of the fracture initiation sites had been obliterated by the corrosion attack. In the left region (40 X SEM, Fig. 15), the sample had fractured by a brittle SCC mode, through the entire thickness of the sample. Small, ductile fracture zones were observed in the center regions of the middle-right and the right-end areas of the fracture. The middle-right, ductile fracture was corroded and is believed to have failed before the uncorroded center ductile region at the extreme right in Fig. 15, which failed last under overload conditions (125 X SEM in Fig. 15).

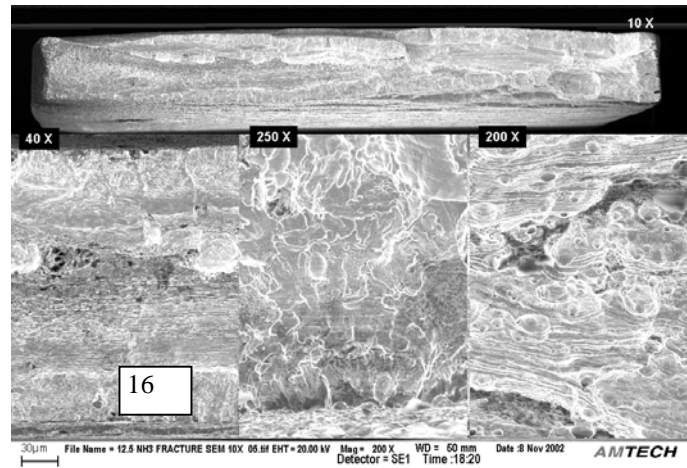
The 12.5 % ammonia-tested sample fracture (Fig.16) had a brittle, smooth appearance through most of its thickness, probably due to a severe corrosion attack as a result of high ammonia concentration. This fracture started at multiple locations on both the surfaces and then rapidly progressed inwards by a transgranular SCC mechanism. The corrosion had completely obliterated the finer fracture features at the near-surface initiation sites. The left region of the fracture (40X SEM in Fig. 16) was brittle through the sample thickness and is believed to have failed first. The middle SEM photo at 250X in Fig. 16 shows a magnified view of the brittle SCC observed near the bottom surface in the middle-right area of the overall fracture. The right end of the overall fracture showed some corroded, ductile fracture (200X SEM in Fig. 16), and is believed to be the region of the final overload fracture in the present sample.
