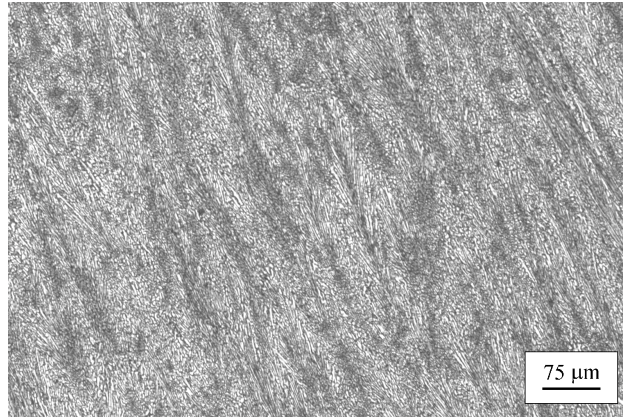
Figure 5.4(d): - A typical micrograph from the test plate for conditions 2 and 4 in Table 5.1. This structure would be described as predominantly eutectic.

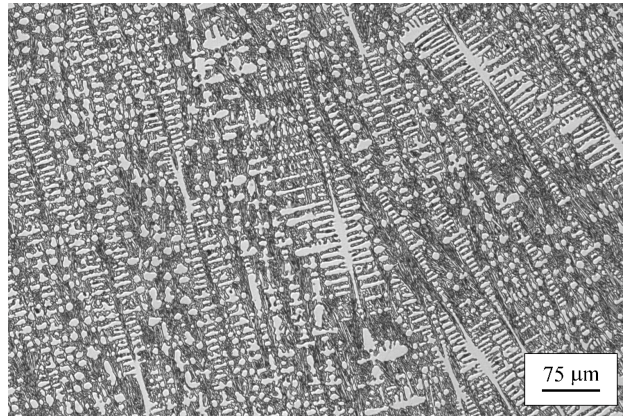
Figure 5.4(e): - A typical micrograph from the test plate for condition 3 in Table 5.1. This overlay was hypoeutectic. Dendrites of austenite can be seen in the structure. The dendrites are surrounded by the eutectic constituent.
