THE TAP PROJECT

F. Marchesani, E. Donati – Snamprogetti, Italy
C. M. Spinelli – Eni Gas & Power, Italy
G. Mannucci, G. Demofonti – CSM, Rome, Italy
M. Cabrini, T. Pastore – Università di Bergamo, Italy

The paper introduces the TAP project, and particularly describes main aspects of the laboratory and full scale experimental campaign addressed to Environmental Assisted Cracking.

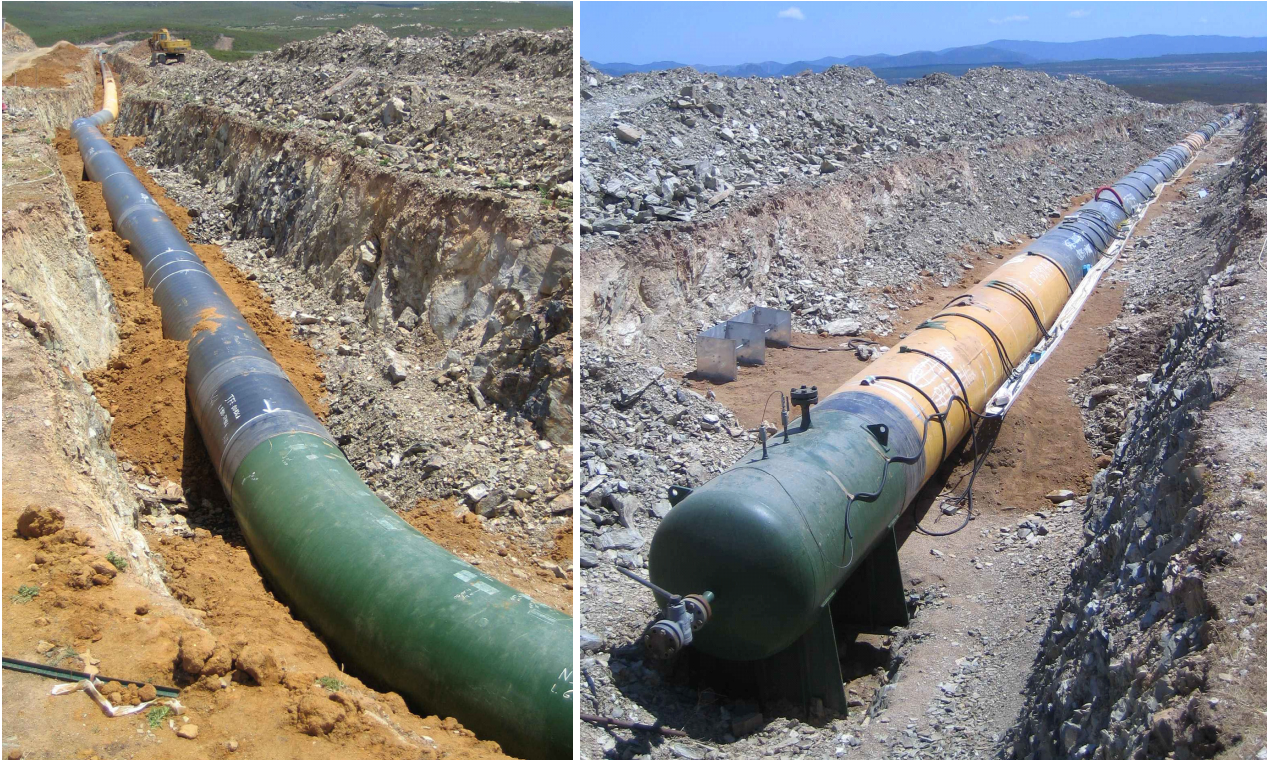
Figure 2 – X100 line A (on the left) and line B (on the right) fully instrumented.

First section (named line A as in Figure 1) is shown in Figure 2 and is built using X100 pipes, field and hot bends and tees, according to the best workmanship standard, as needed for a real long distance gas transmission pipelines. Two crack arrestors have been inserted inside the line, because at the end of the “operating period” a full scale ductile fracture propagation burst test will be performed to study the fracture propagation and arrest behavior of X100 pipes after a significant time interval in service. As main target, it is intended to qualify crack arrestor capacity after a relevant “operating period”. It is well know that this class of steel does not guarantee the fracture arrest basing upon pipe body toughness only. As a real gas pipeline, line “A” section will have a standard cathodic protection, about -850 mV vs SCE, and it will be monitored using a remote system. Figure 2 shows line A as built.

The second section (named line B as in Figure 1) is shown in Figure 2, and is dedicated to study the influence of the environment on the long term structural resistance of damaged pipes. Third party damages affecting the steel, pipe coating rupture and failure of field joint coating, are investigated. As far as third party damages are concerned, two different kinds of mechanical damage are studied, which are gouge and dent & gouge defects (Figure 3), realized using the full scale test aggression rig of Figure 4. For large diameter-high thickness (>15.0mm) and high grade steel, the puncture/failure of the pipe is a very remote event. The delayed failure of a pipe that presents a permanent damage, not resulting in an immediate failure, can occur if coupled with the environmental action (over cathodic protection for instance) and stress rate variation (due to the internal pressure fluctuation). The same can be said for other types of damages considered, which are for instance the presence of on purpose realized coating “defected zones” upon few of the girth welds.

At the moment both lines A and B have been completed and are subjected to internal pressure fluctuation from 13.5 to 15.0 MPa with a frequency of about 10 cycles per day.

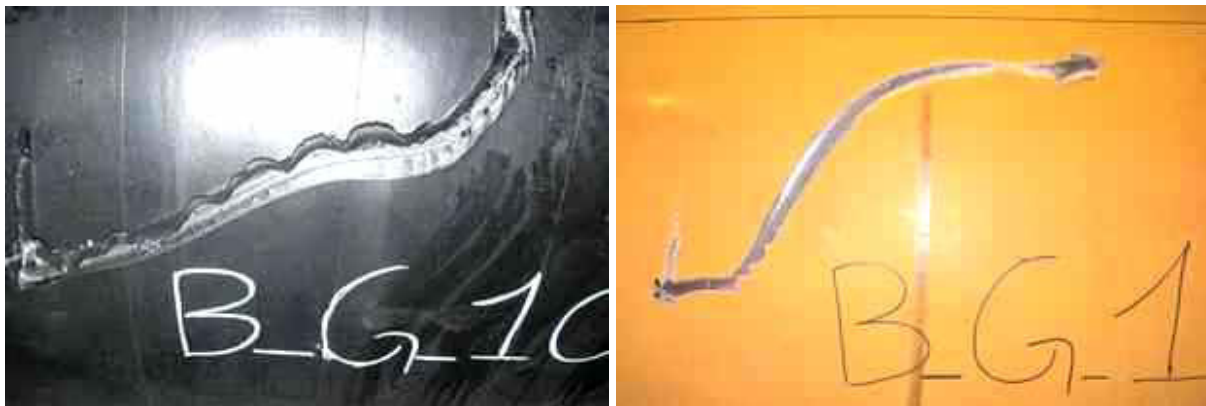
Figure 3 - Example of third party damages realized on line B coated pipes (FBE coated pipe on the left and HDPE coated pipe on the right).

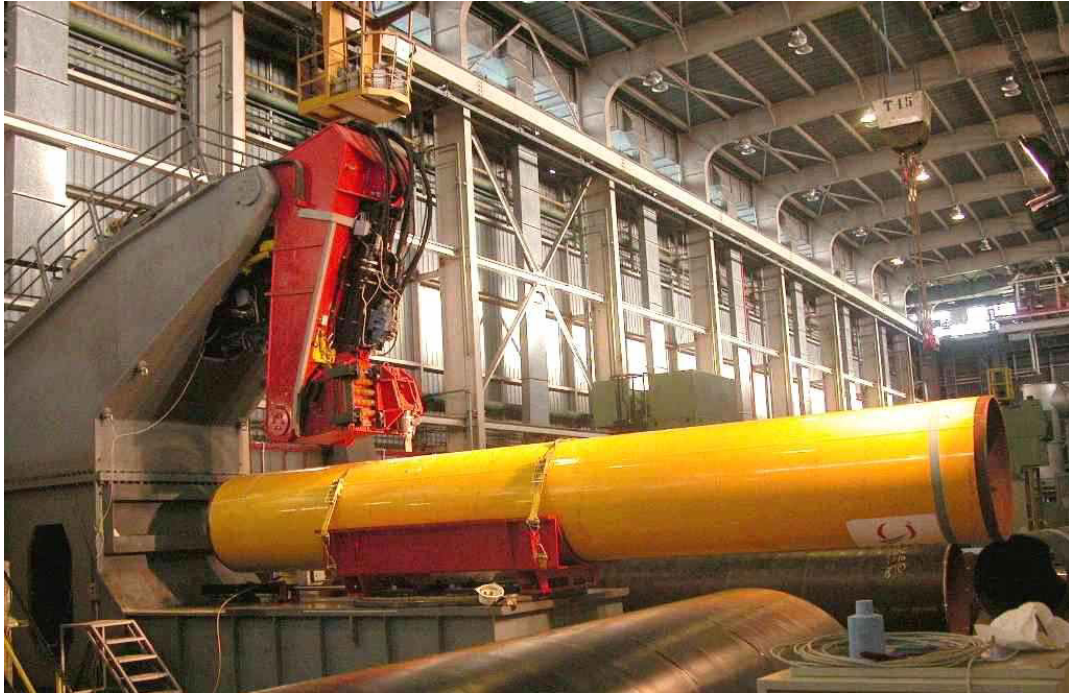
Figure 4 - CSM's full scale test aggression rig "Simulator" with a FBE coated pipe ready to be damaged (TAP project)

Damaging tests of interest were performed on API X65, 36" OD x 14.9 mm wall thickness pipe and on X100 36" OD x 16.4mm wall thickness pipe. The simulated excavator was a large one, with about 33 tons of operating weight. Table 1 reports main properties of the tested pipes, while main parameters adopted during the external damage testing are reported in Table 2. Pipe samples were pressurized with 100% water for safety reason; the use of water instead of gas, looking at the very low amount of medium volume which is compressed during the impact, does not affect significantly the result. Note that both pipes, even though different in steel grade, exhibit the same diameter (36") and were pressurized at the same usage factor (about 50%SMYS). Main results are reported in Table 3.

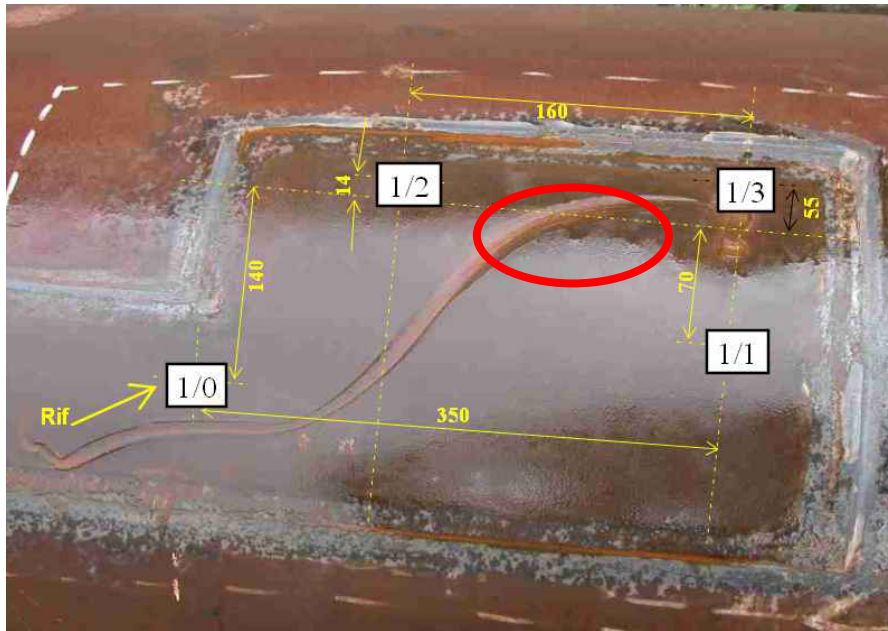
Figure 5 – Dent and gouge damage on X100 pipe with indication about strain gauges and failure location (red circle), dimension in mm.

The X100 damaged pipe sample was instrumented with strain gauges (Figure 5) for monitoring damage evaluation during the test where internal pressure fluctuation cycles were applied with a local strain rate of about $1.4 \cdot 10^{-6} \text{ s}^{-1}$. Strain gauges position were defined by means of finite element analysis of the damaged pipe starting from the result of the 3D optical device measurement as previously mentioned; mesh for the FEM analysis was directly derived from the surface scanning measurements, and this allowed to identify the areas close to the defect which are more sensible with respect to pressure fluctuation.

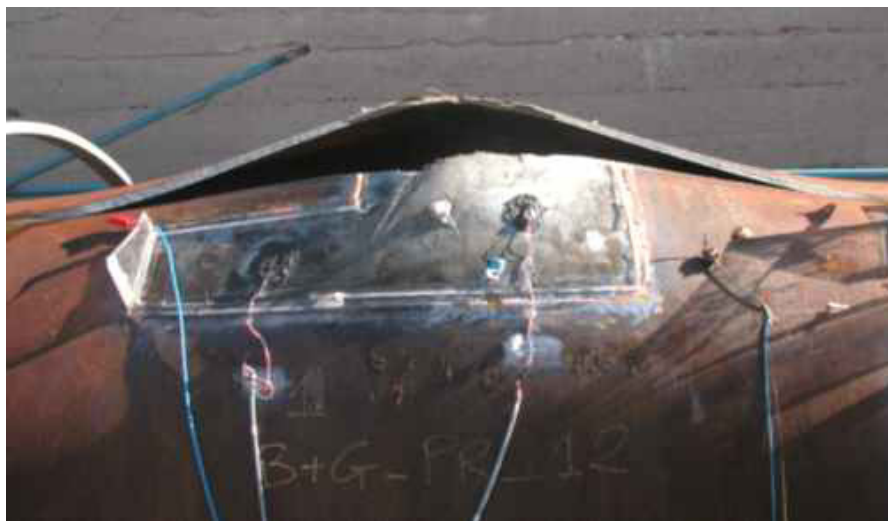
Figure 6 – View of the X100 damaged pipe after the failure

A total number of 42.600 cycles was suffered by the damaged pipe before fails. A compliance variation was recorded by strain gauges in the last part of the test just before the failure. Photo of the failed sample is reported in Figure 6. It has to be noted that several additional cracks were detected close to the main one.

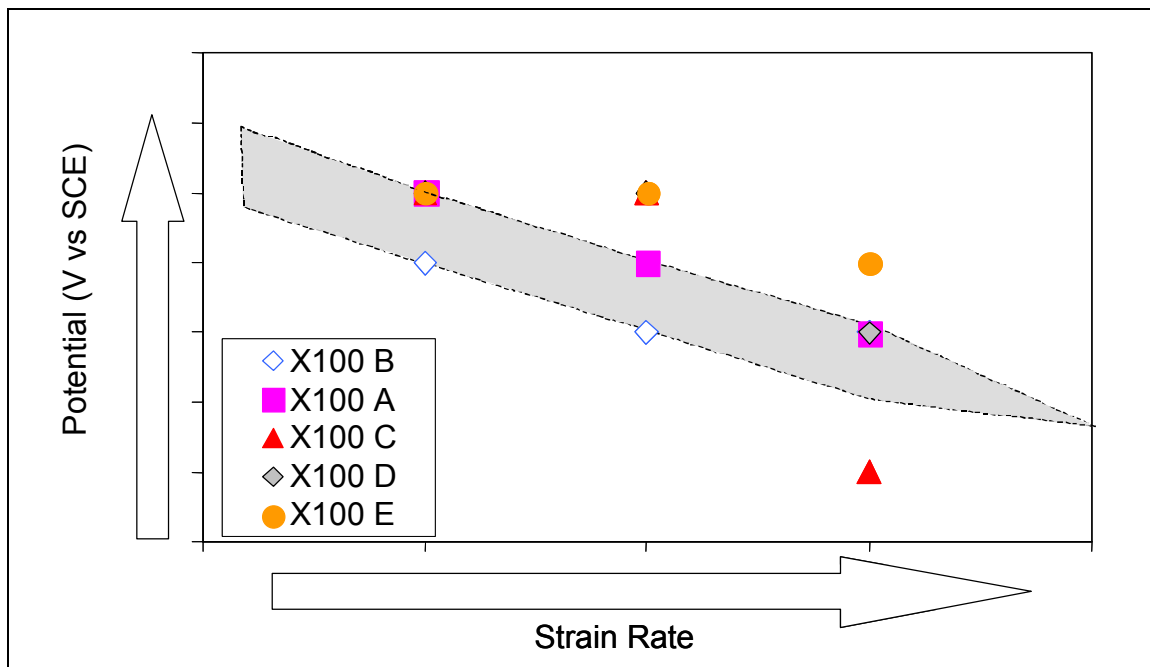
Figure 9 – Qualitative trend of critical potential to have hydrogen embrittlement phenomena as a function of strain rate for the examined X100 steels

Figure 9 shows qualitative trend of critical potential inducing hydrogen embrittlement for each steel as a function of strain rate. The grey area represents the field of hydrogen embrittlement insurgence for traditional ferritic/pearlitic linepipe steels. It can be noticed that the general trend observed was that lower the strain rate applied, higher the potential value found to be significant.

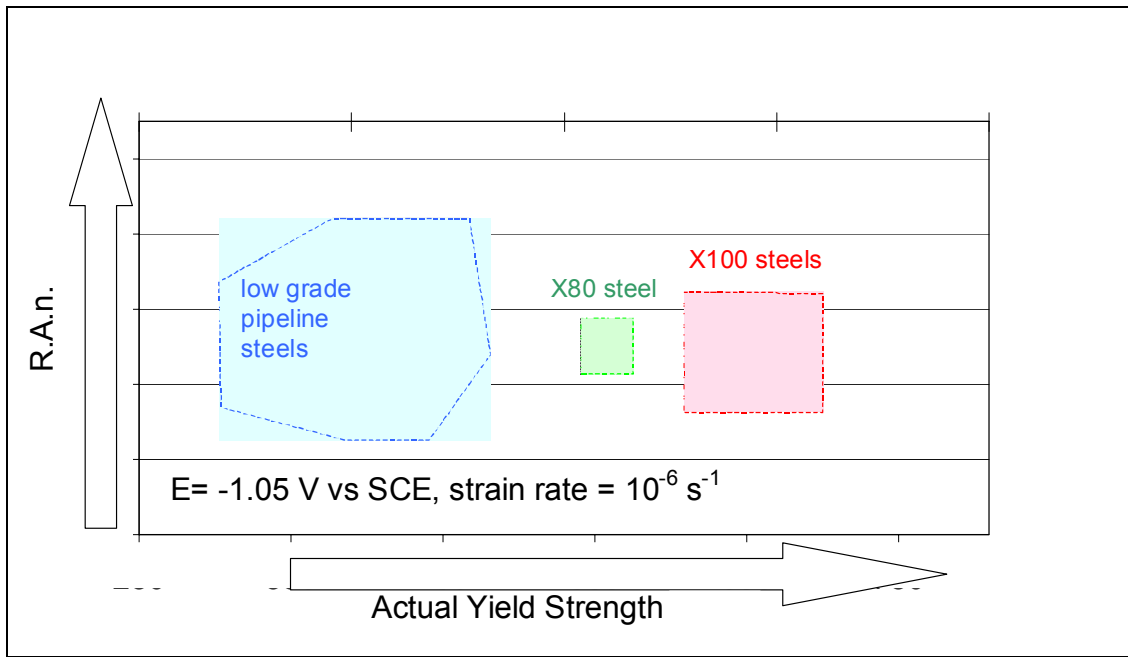
Figure 12 - Effect of Normalised Reduction of Area of the specimens after the SSR tests in NN-SCC environment

Being the NN-SCC mechanism recognised as an hydrogen embrittlement one, it is expected that the behaviour of the X100 steels in this environment should be similar to those observed in cathodic protection. The Normalised Reduction of Area obtained for the X100 steels in NN-SCC environments are compared with those of the low grade pipeline steels in Figure 12. The presented results are still preliminary, but it seem that some X100 steels have a behaviour similar to the low grade steels, but for other X100 cases the susceptibility to the NN-SCC increases as the actual Yield strength increases.
