10AW2 (Ni-rich) BADA optical micrographs

Polished to a depth of $\sim 240 \mu\text{m}$
below the surface

Projectile travelled in the $-z$ direction

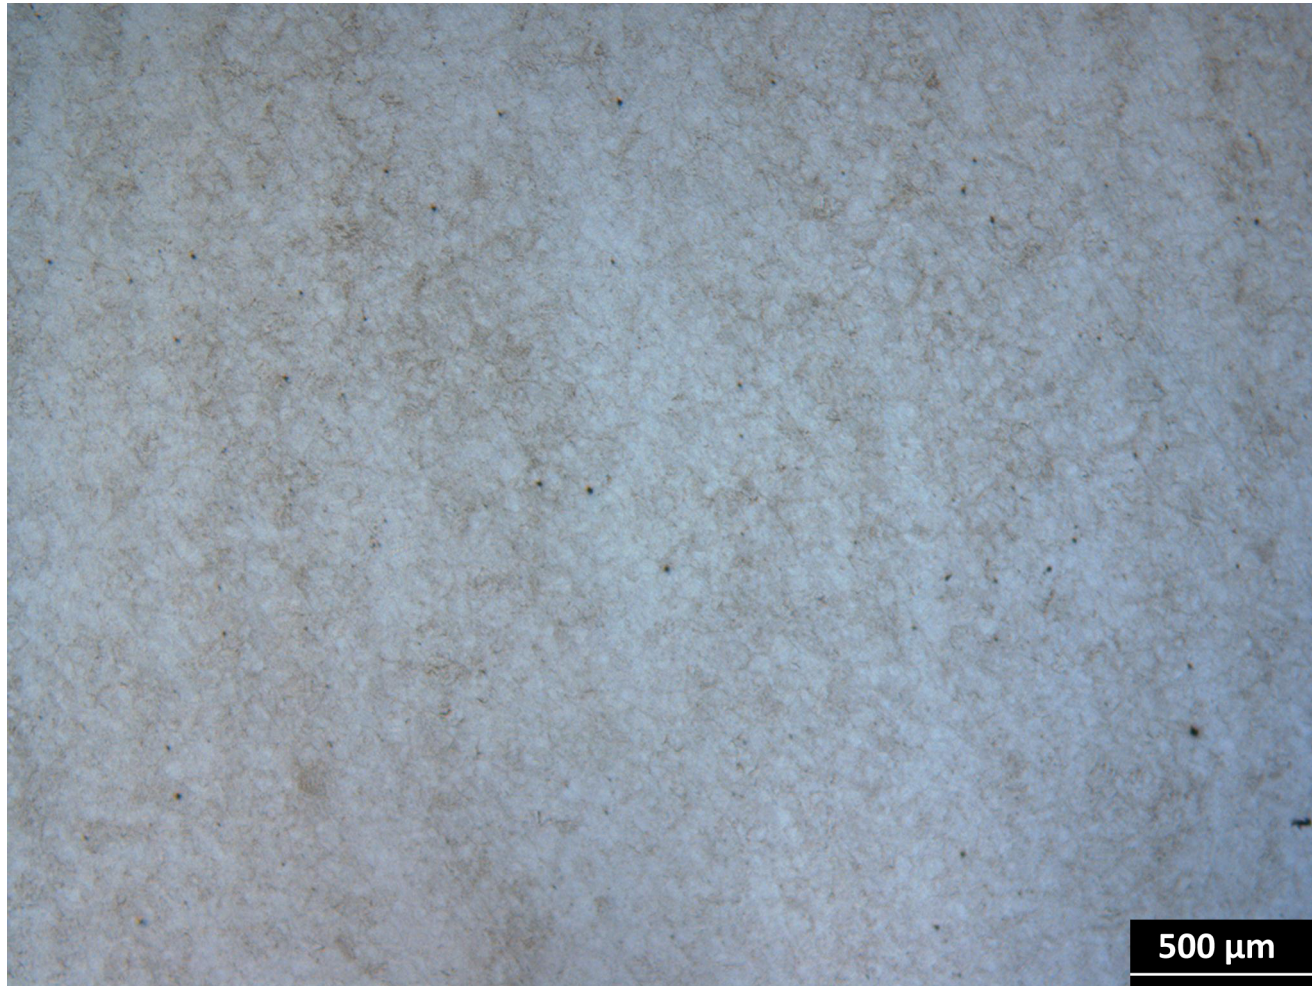
Micrograph taken at a distance from
the hole

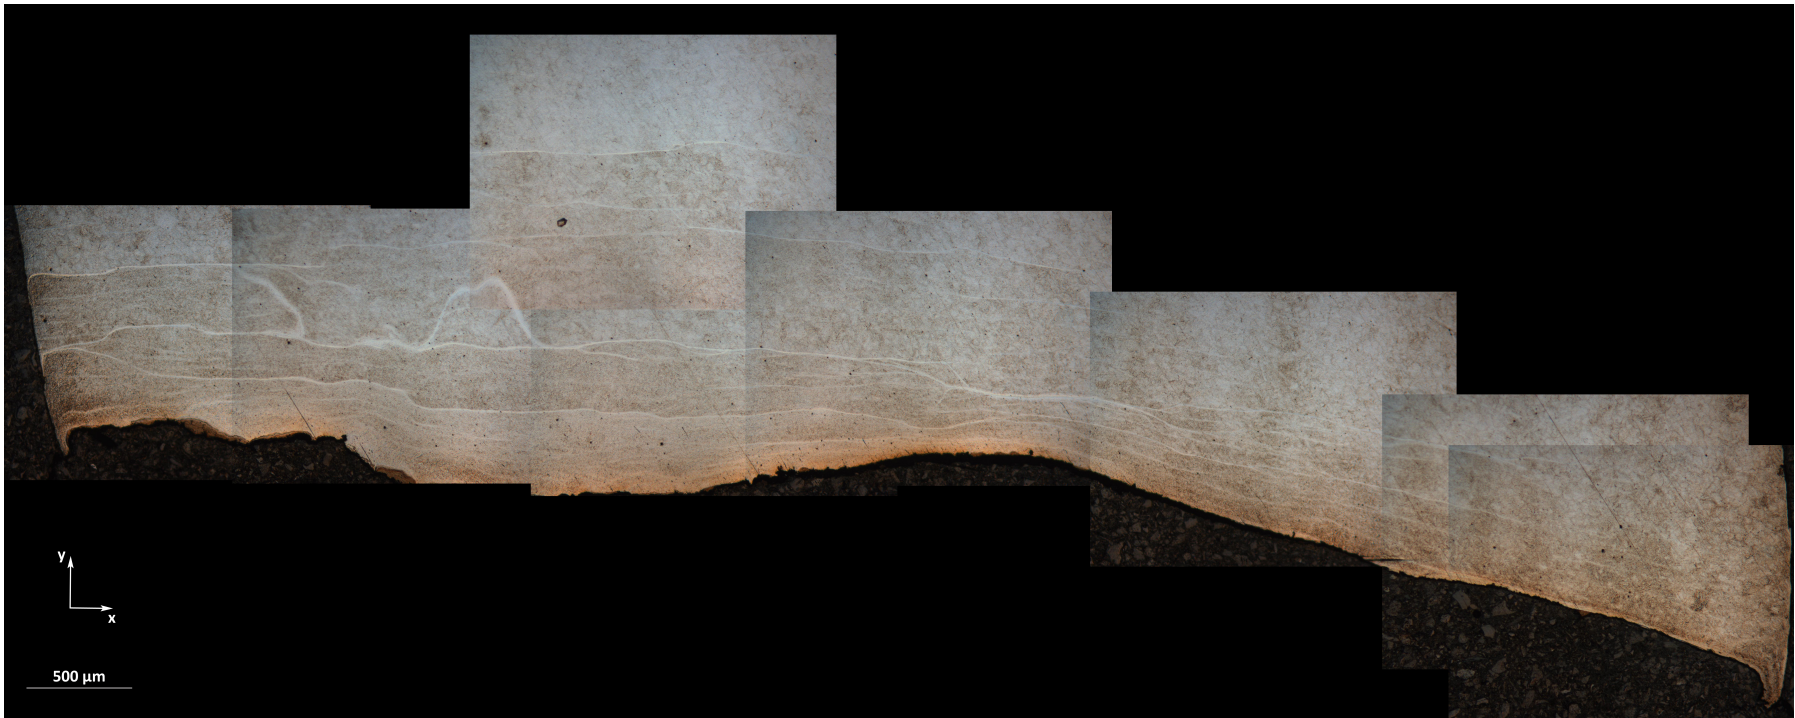
Higher magnification image of shear bands

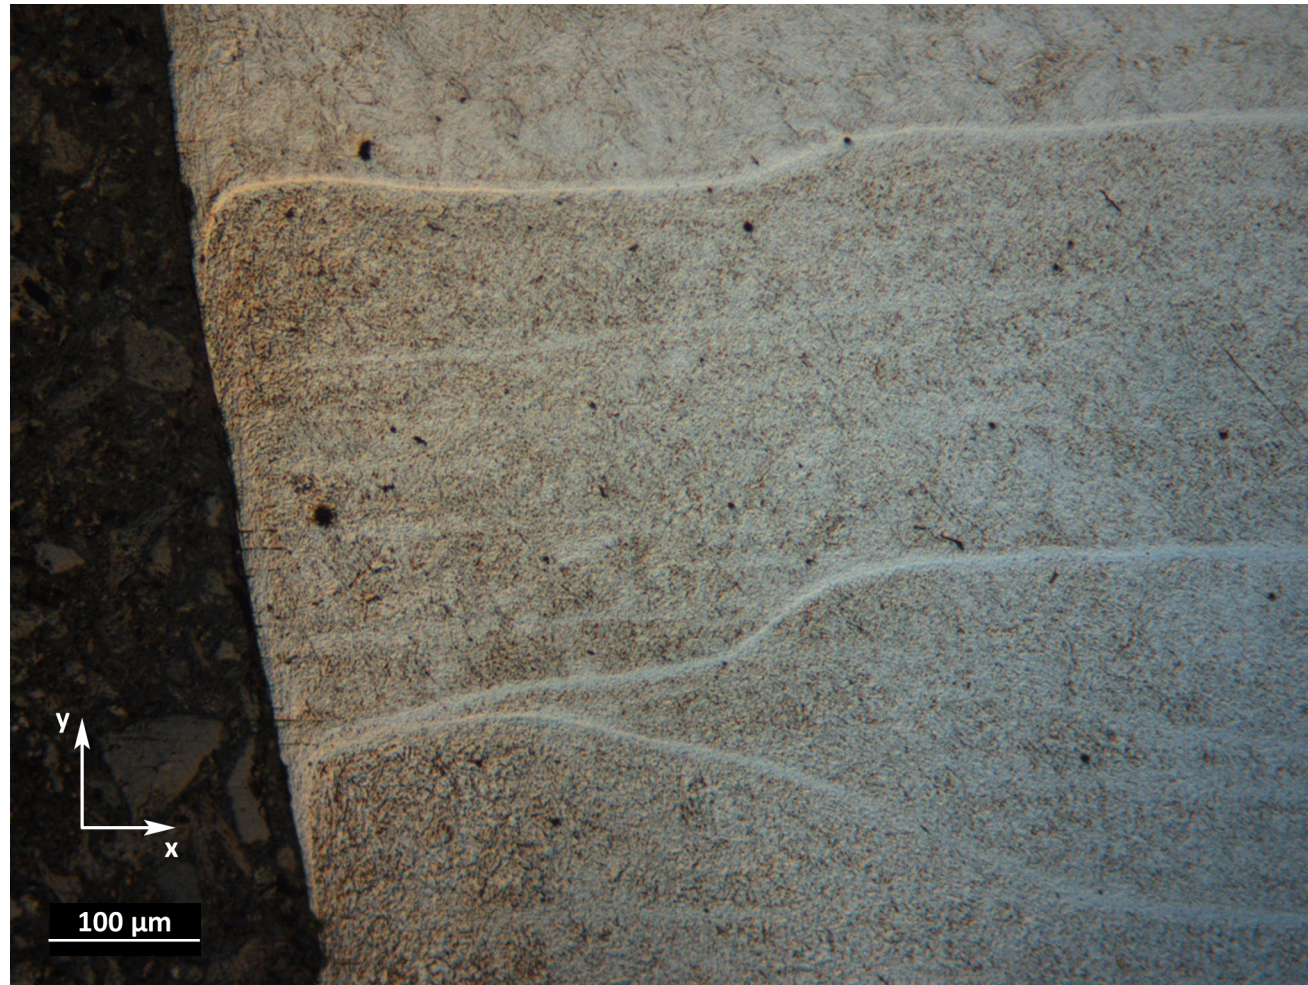
Material face on the LHS is where the sample was machined to cut it from the plate.

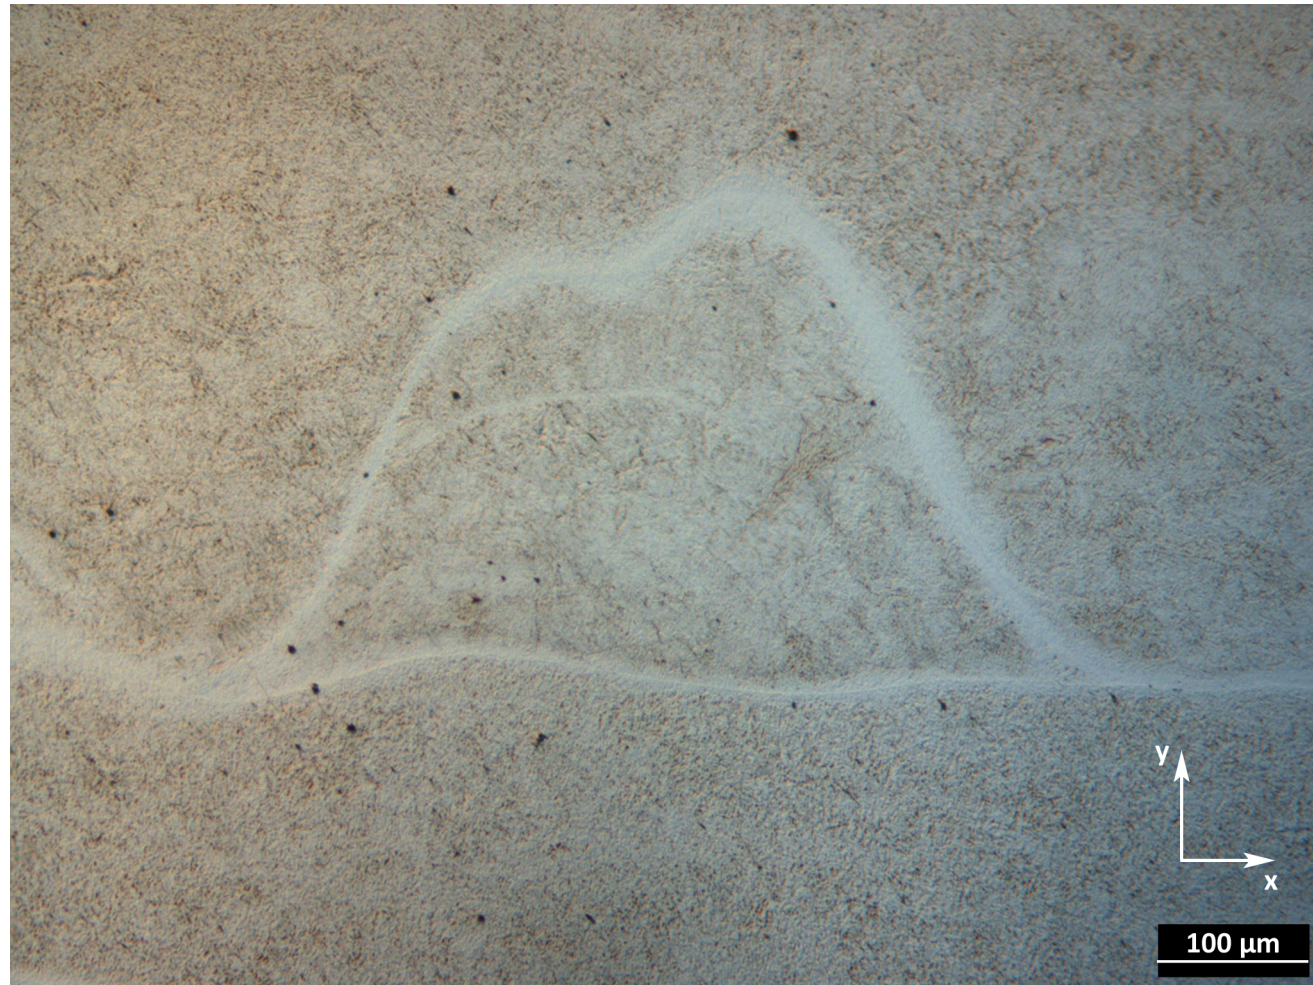
Close up of shear band

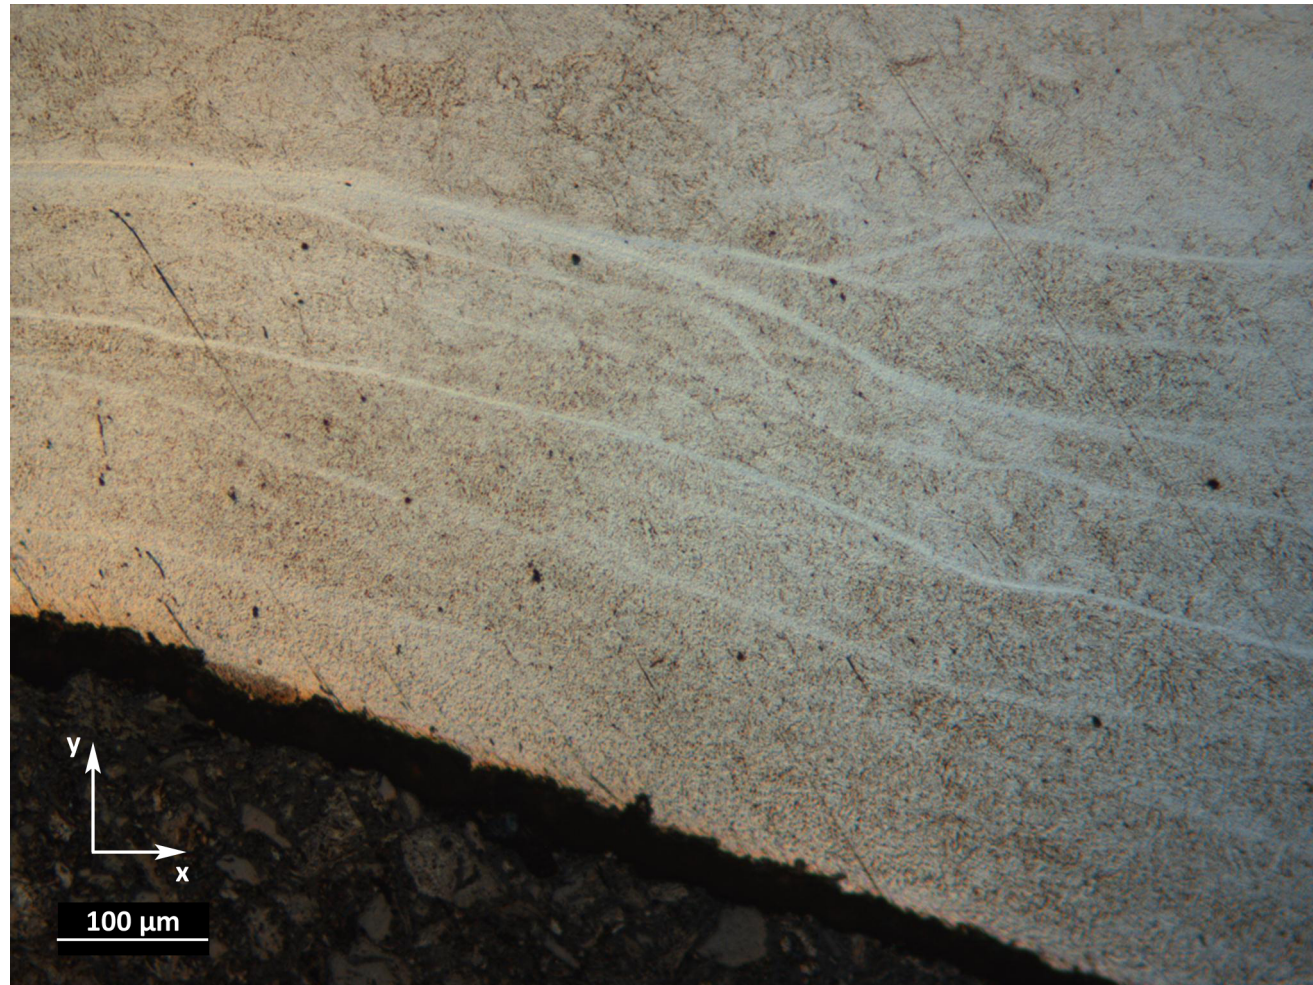
Shear bands close to hole

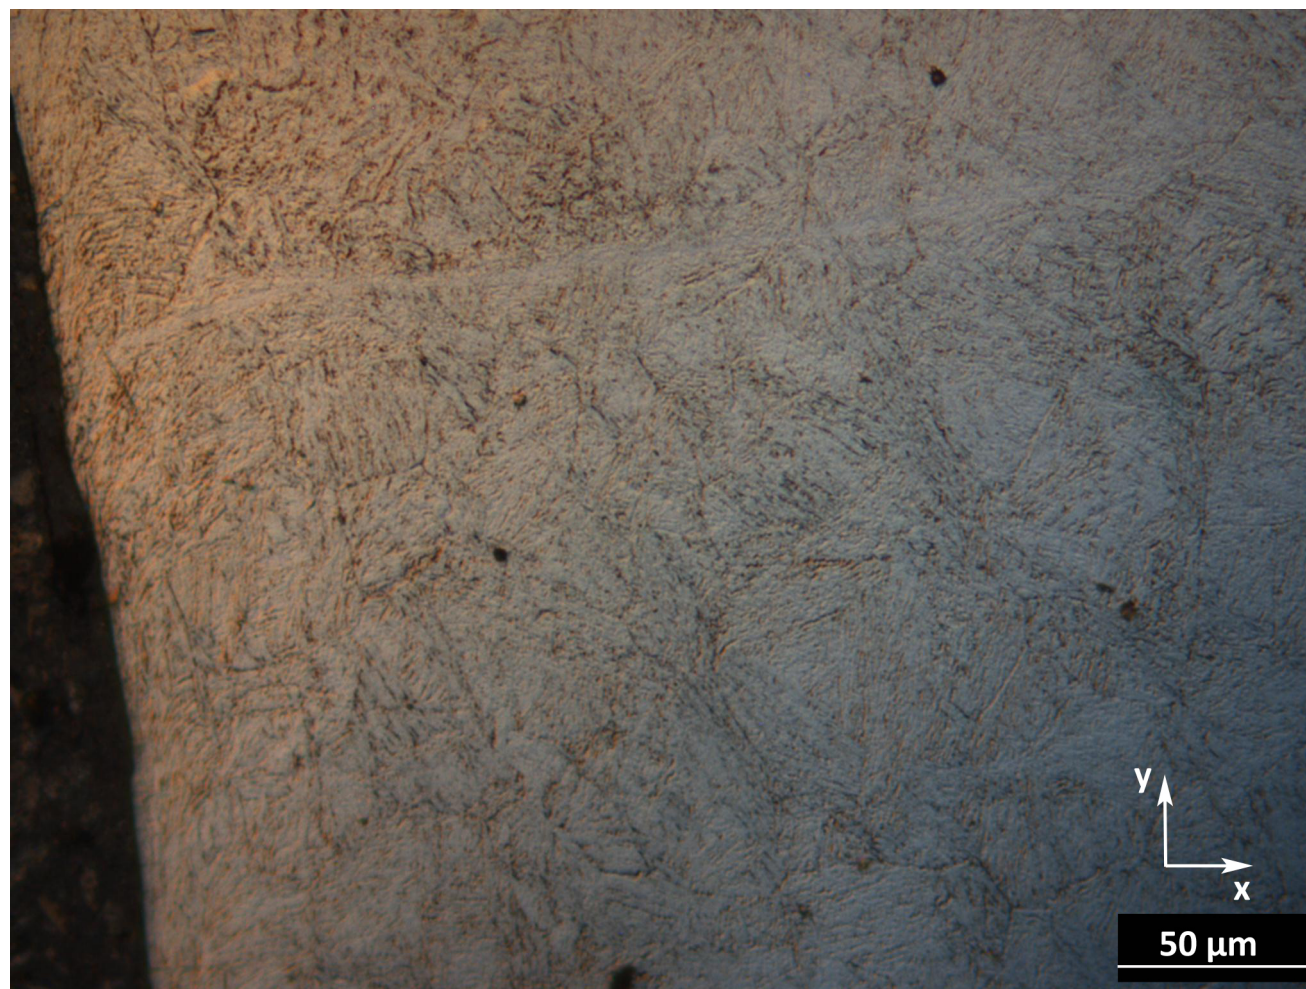
Appears to be microstructural change here compared with the material in the previous 3 images

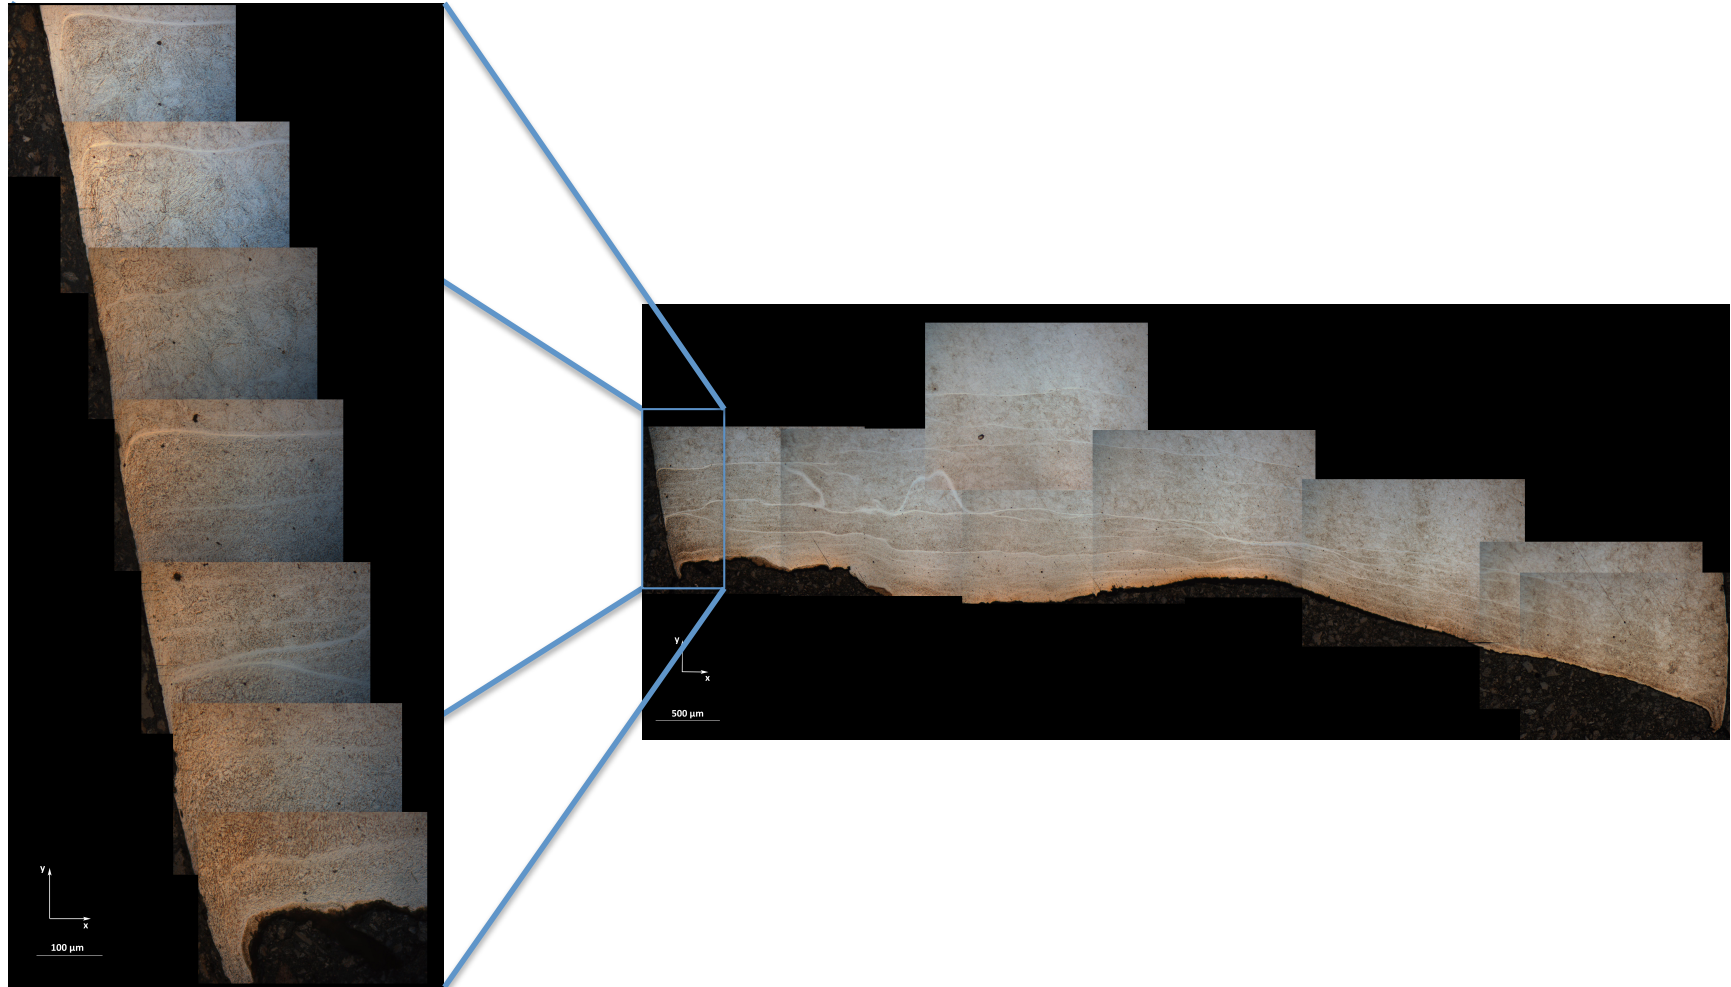
Location of higher mag. images
