DEGRADATION OF MATERIAL PROPERTIES OF A CUPRONICKEL ALLOY IN AMMONIACAL ENVIRONMENTS

**Commander DC Agarwal, Indian Navy and Commandant (JG) Alankar Singh Indian
Coast Guard**

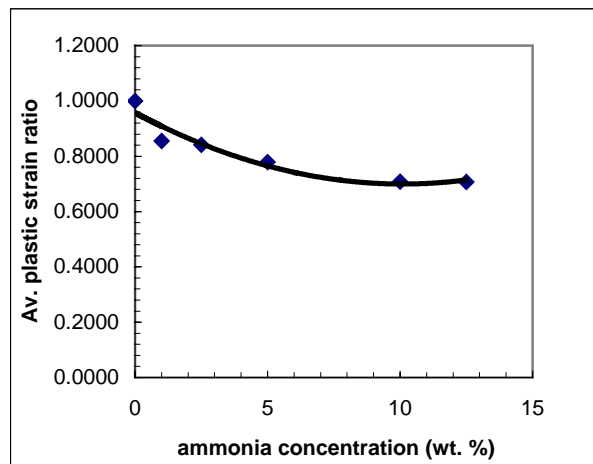
The air tested sample displayed the mechanical strength values similar to that observed in the earlier tests [9,10,12]. Both the load-bearing capacity (UTS) and the plastic strain ratio dropped steeply with ammonia concentrations upto 2.5%, and then changed gradually to become flat beyond ~7% ammonia, as indicated in Fig 1. The UTS dropped from 307.57 MNm^{-2} in the inert environment to 216.12 MNm^{-2} with 5% aqueous

Fig. 1 Ammonia concentration to average plastic strain ratio
